**Re: Tyler Cole v. Shelter Mutual Insurance Company
Case No. CIV-13-1178-M
United States District Court for the Western
District of Oklahoma**

Background

- 1.1 Tyler Cole claimed that his home, located at 918 West Kyle Way, Mustang, Oklahoma suffered damages as a result of the storm activity.
- 1.2 The subject residence was a single level home with a masonry veneer and a 3-tab asphalt composition shingle roof system.

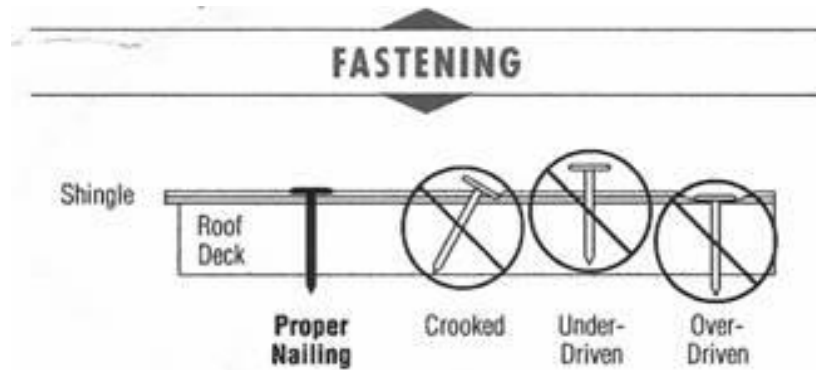
- 2.1 File documentation indicates improper nailing of the shingles. The inconsistencies include: fewer nails than required by industry standard, improperly placed nails, canted nails, overdriven nails and underdriven nails. The following diagram reveals some of the characteristics of proper and improper nailing of asphalt shingles and what has been observed at the subject residence:

2.2 Overdriven and underdriven nails can either prevent a shingle tab from sealing or cause the shingle tab to only partially seal. "Under driven" nails position the head of the nail in such a manner that it can cause undulations in the surface of the shingle which covers it.
